# Immediate implant placement and graft in extraction socket

## PATIENT BACKGROUND

This patient presents with failing LR5 (45) & LR6 (46) due to secondary decay. The teeth were extracted, and the infected tissue was removed.

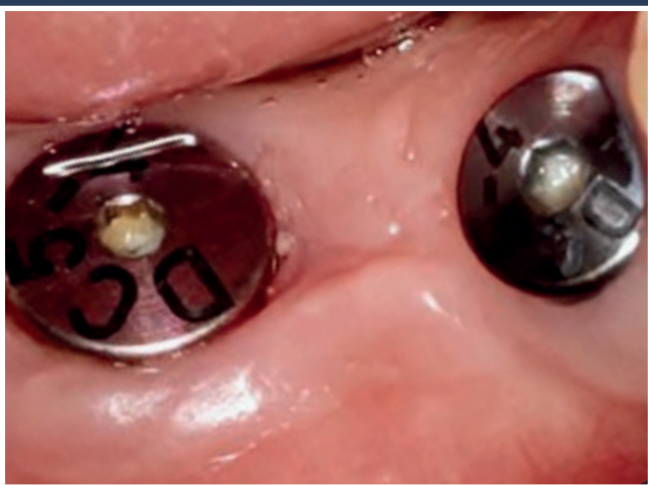
7. Healing at 12 weeks

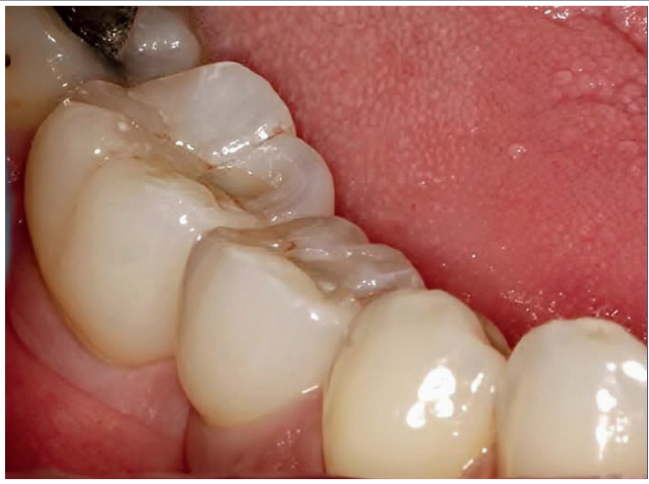
9. Fitted crowns

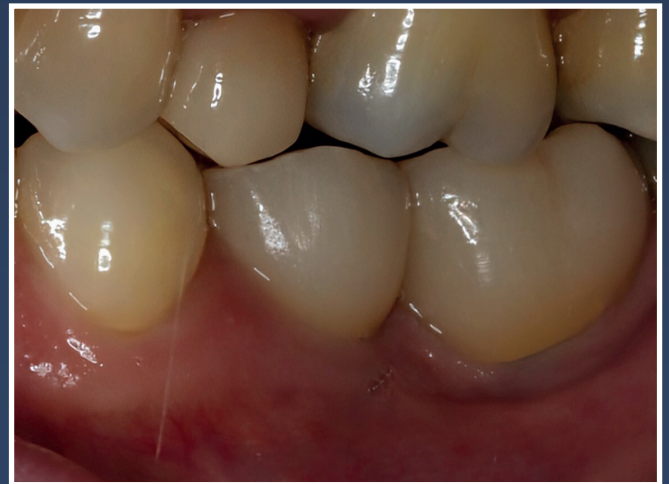
14. Review - 5 years post-op

This case demonstrates the option to leave EthOss Bone Graft uncovered in the clinical situation, as shown with excellent long-term hard and soft tissue outcomes.

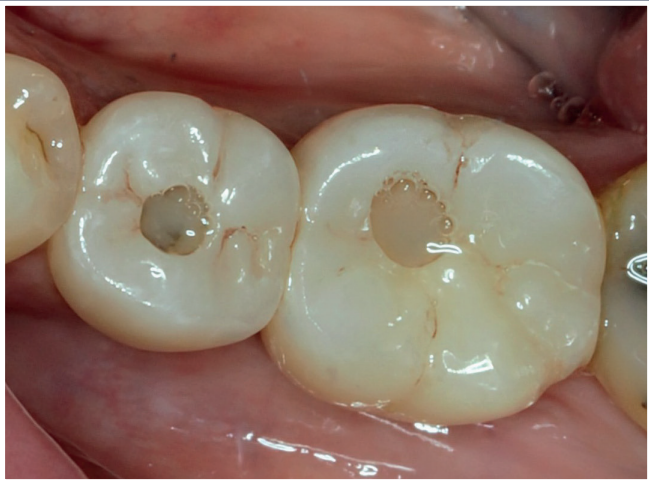
15. Review - 5 years post-op
